March 19, 2015
ADDENDUM #2
TO
REQUEST FOR OFFERS TO PURCHASE
FOR
THE SALE OF REAL PROPERTY
HOWARD COMMONS

EXHIBIT A
Weston Report 3028 Pinebrook Housing

PINE BROOK HOUSING

3028.1 GENERAL

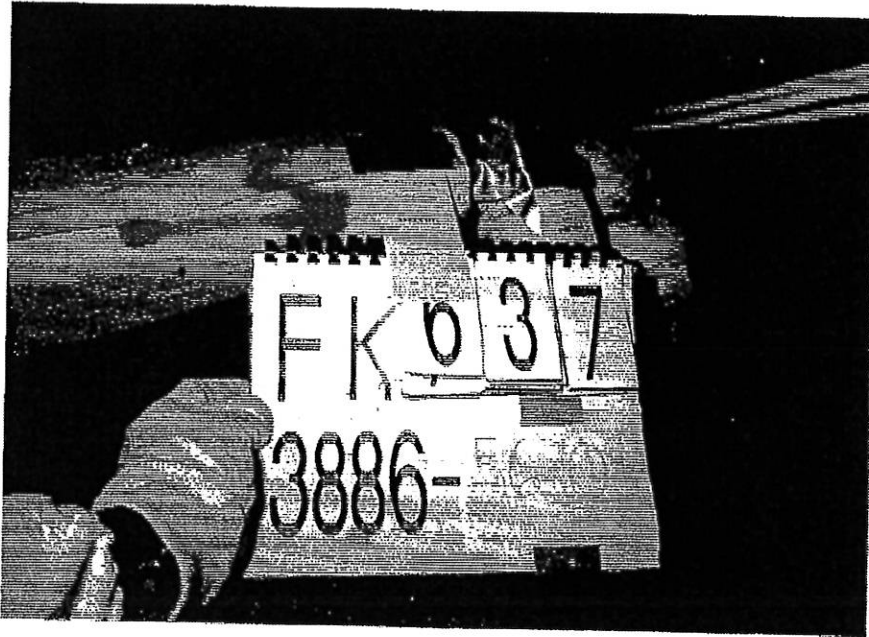
Bldg. 3028 - Crawlspace: Less Than 4" Fitting Sample FK637 Tested Positive.

- Asbestos-containing floor tile and pipe run and pipe fitting insulation should be labeled under the O&M Program.

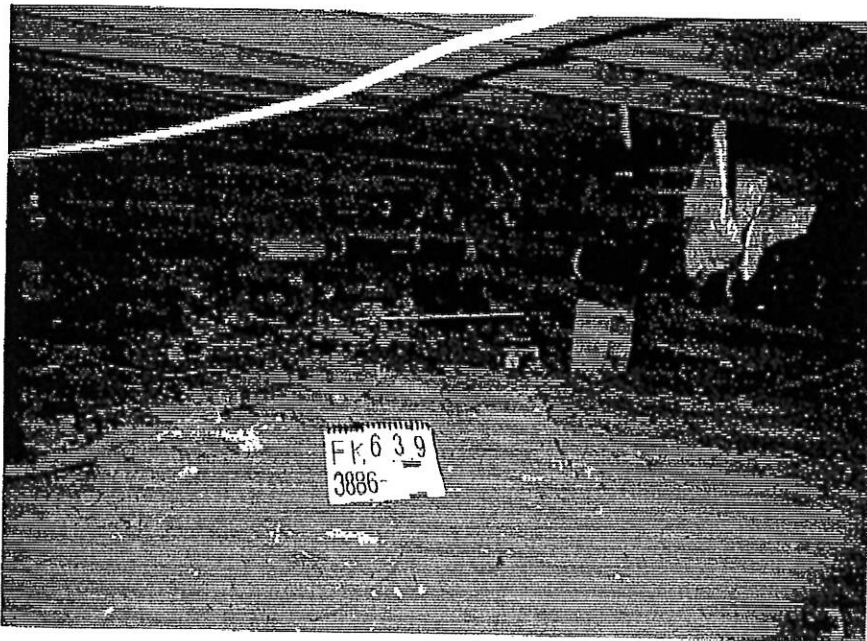
Bldg. 3028 - Crawlspace: 4" - 8" Fitting Sample FK639 Tested Positive.
