**Addendum #3
November 30, 2016
To
REQUEST FOR OFFERS TO PURCHASE
FOR
THE SALE OF REAL PROPERTY
AND PERSONAL PROPERTY
Fort Monmouth
Suneagles Golf Course and Associated Facilities
Eatontown, New Jersey**

RE: Asbestos Survey of Family Housing Units in the Megill Area

Between 04 June and 15 July 2014, I conducted walk-through surveys for existing asbestos containing material (ACM) in the Fort Monmouth Family Housing units in the Megill Area, (Buildings 2022 thru 2042). Per Wanda Green the purpose was to document current conditions of previously identified ACM from the Weston Report of 1991. See attached. In addition, current AHERA (Asbestos Hazard Emergency Response Act) due diligence has identified other materials/products that were used in construction before the ban of asbestos. Where samples of suspect materials could be collected without destructive techniques, they were collected and analyzed by an accredited laboratory.

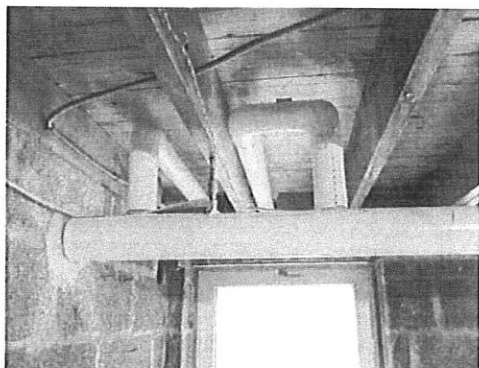
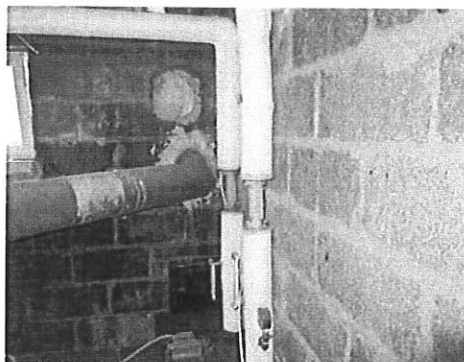
Remediation of the horizontal heating pipe runs, below the ceiling, was accomplished in all of the units. Fiberglass insulation was used to replace what was removed. It remains in good condition. Photographs of typical conditions are given here.

Typical new fiberglass pipe insulation in the basement.

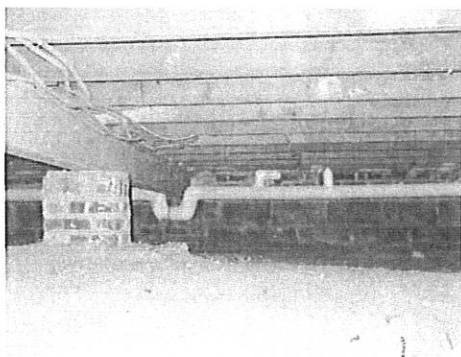
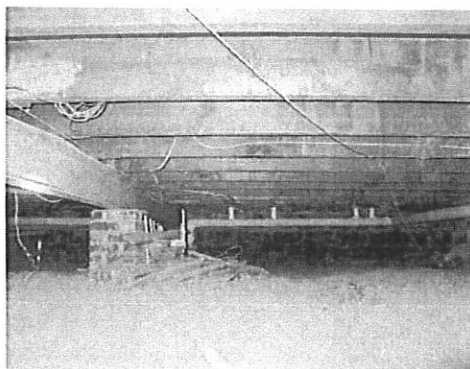
Typical new fiberglass pipe insulation in the crawlspace.

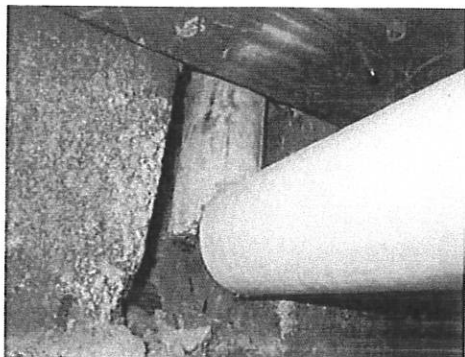
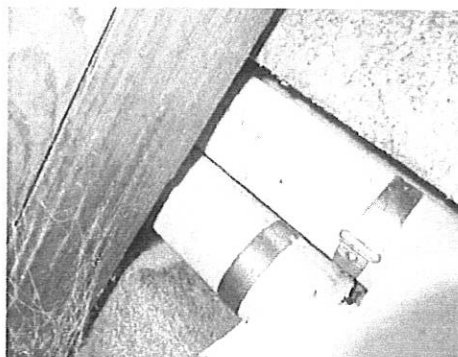
The horizontal heating pipe "below the ceiling" was remediated. Remediation stopped at the elbow where the vertical risers go up to the first and second floor radiators. The first floor risers are not insulated being that the radiators are just above the basement ceiling. The second floor risers are concealed behind the first floor walls. They can be seen coming out into the basement. The style of this TSI is typical of thermal system insulation ACM and is presumed to be ACM (PACM). Samples of this material were not taken since presumption of asbestos is indicated.

PACM visible going behind the wall on Second Floor risers.

PACM is only visible in three housing units. It is in good condition and it is virtually inaccessible. In the remainder of the units the remediation crew packed fiberglass around the PACM as an extra level of protection.

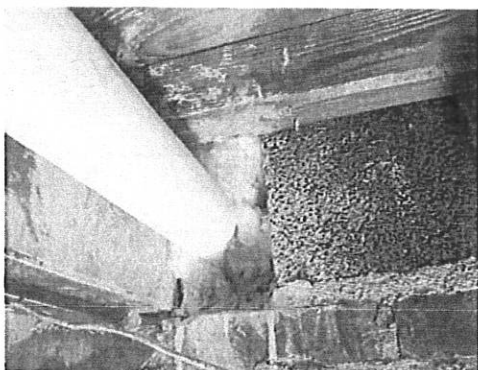
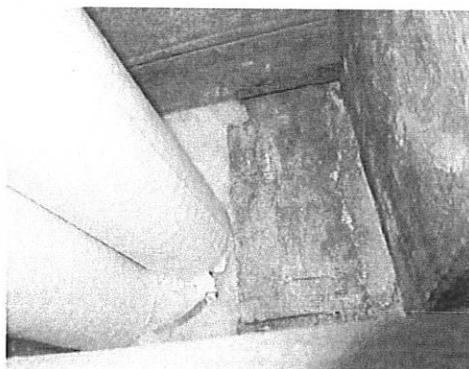
Typical view of the fiberglass packing to protect the PACM.

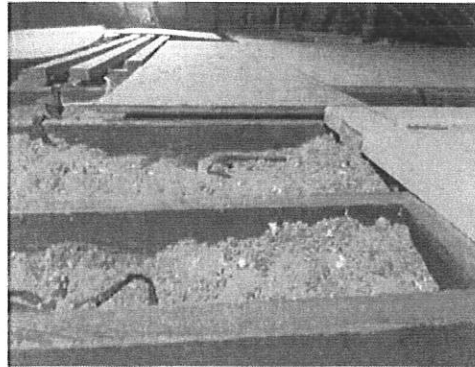
The attics in the Megill Housing Area are accessible through an interior pull down stairs. The attic floors are insulated with a brown poured-in material. Weston tested this material and reported it as non-asbestos.

Typical attic insulation.

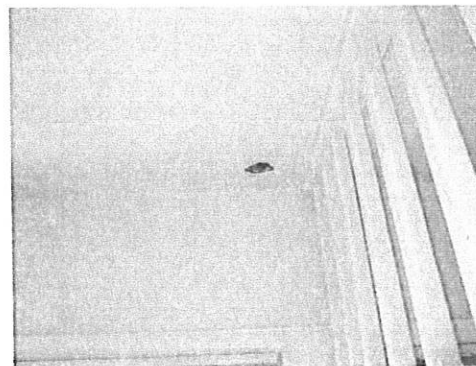
Ceiling Damage Sampled
