## 3.17 Parcel 70 – Bldg 551 – Former Photoprocessing

## **3.18 Parcel 76 – 200 Area, 300 Area – Former Barracks**

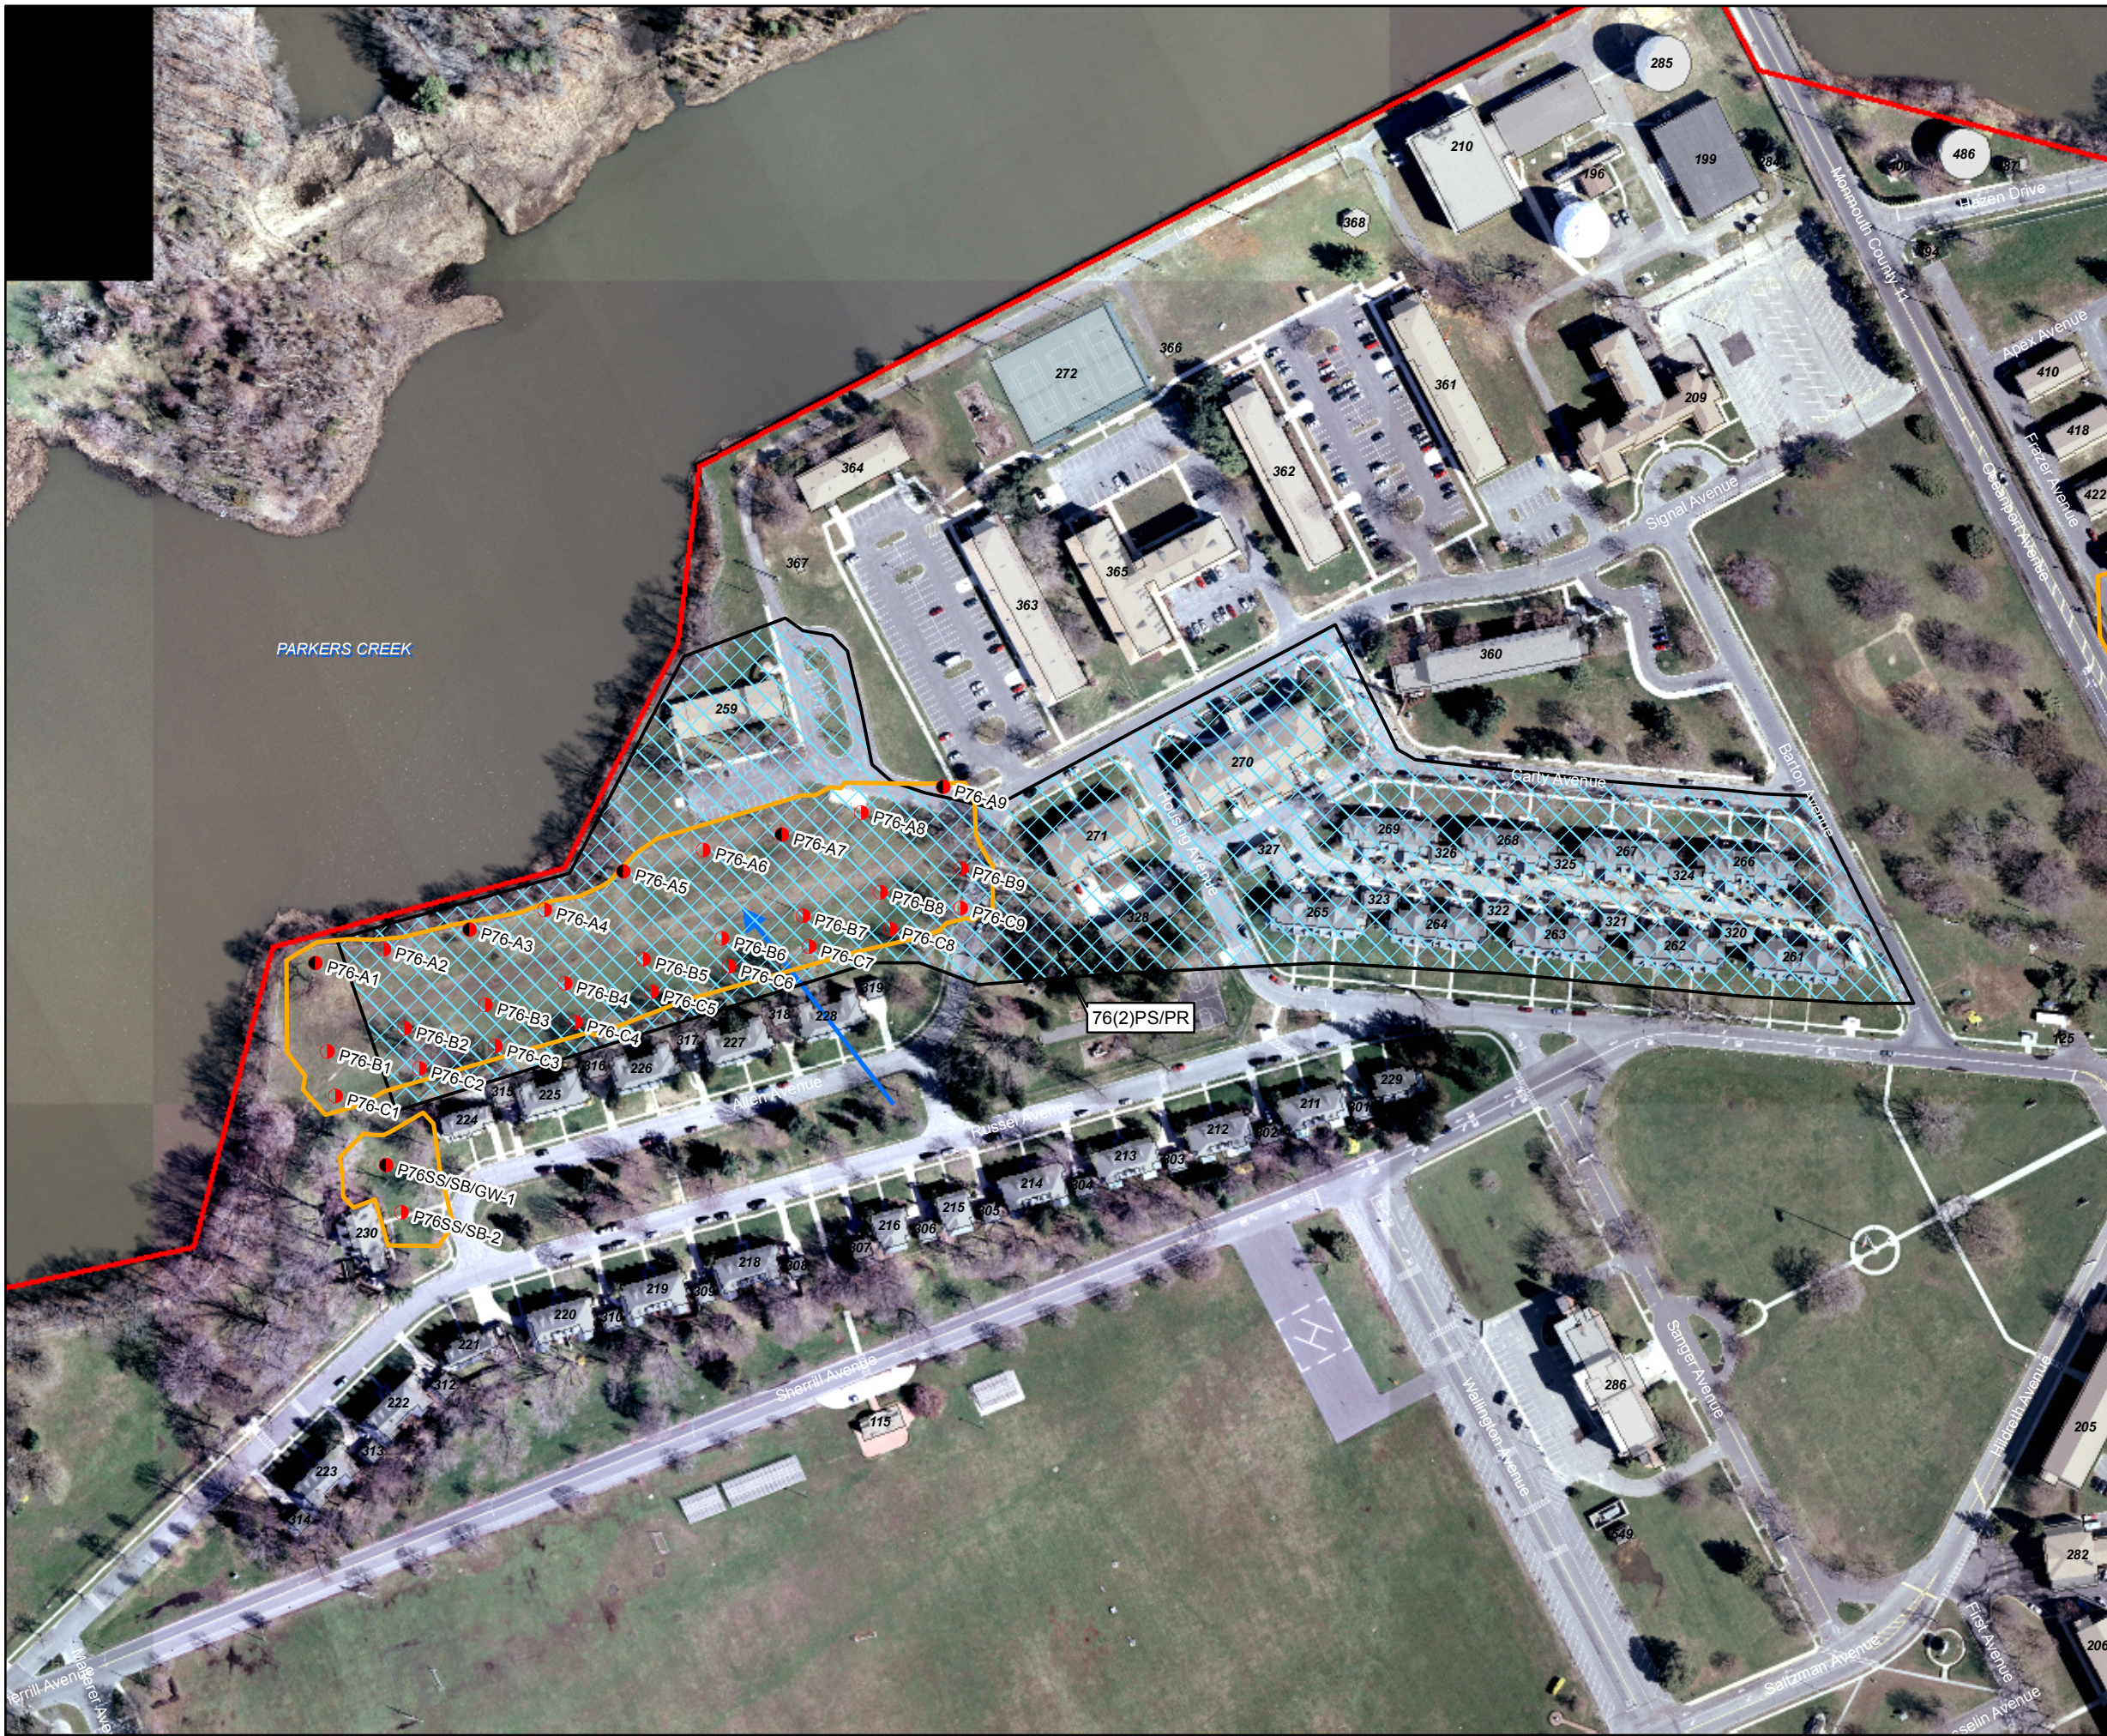
**FIGURE 3.18-1**  
**FORT MONMOUTH ECP**  
**SITE INVESTIGATION**  
**PARCEL 76 SAMPLE LOCATIONS**  
MAIN POST  
FORT MONMOUTH  
NEW JERSEY

Soil and groundwater samples were collected in November 2007 in Parcel 76 in order to determine if contamination exists from potential historical UST releases. A total of 29 surface soil samples and 35 subsurface soil samples (including five duplicate samples) were collected from 29 distinct Geoprobe® borings (**Figure 3.18-1**). Boring locations were conducted on approximate 100-ft centers in an open field that was once a barracks area. Two additional boring locations were placed near Bldg 230 in January 2008 to investigate a potential heating oil tank. Surface soil samples for non-VO analysis were collected from the 0- to 6-inch interval bgs. For borings located in paved areas, non-VO surface soil samples were collected from the 0- to 6-inch interval directly below the pavement sub-base. Surface soil samples collected for VO analysis were

collected from the 18- to 24-inch interval bgs. Subsurface soil samples were collected from the 6-inch interval directly above the water table. Field screening of the core was conducted using a PID/FID meter. Visual staining and olfactory evidence of impacted soil was noted at the 6-inch interval directly above the water table at boring location P76-B7. Visual staining and olfactory evidence of impacted soil was also noted at boring location P76-C4. One additional subsurface sample, P76-C4-D, was collected based on elevated results from field screening tests that were performed on the soil core at boring location P76-C4.

A total of six groundwater samples (including one duplicate sample) were collected from five distinct temporary wells that were installed with the Geoprobe® rig (**Figure 3.18-1**). Temporary wells were installed along the downgradient (northern) boundary of the soil grid. Two groundwater samples, 76GW-1 (including one duplicate), were also collected from a temporary well installed downgradient of Bldg 230 to investigate possible contamination from a potential heating oil tank that was associated with this building. Temporary wells were constructed of PVC and 5 to 10 ft of factory-slotted screen.

**Table 3.18-1** presents a summary of all field activities, and all sample locations are provided on **Figure 3.18-1**. A summary of sampling activities, including sample IDs, collection dates, and analytical parameters, is provided in **Table 3.18-2**.

Soil and groundwater analytical results suggest that a release has not occurred. In light of the absence of evidence of a release to the environment, NFA for soil, groundwater, and the suspected USTs in Parcel 76 is recommended.

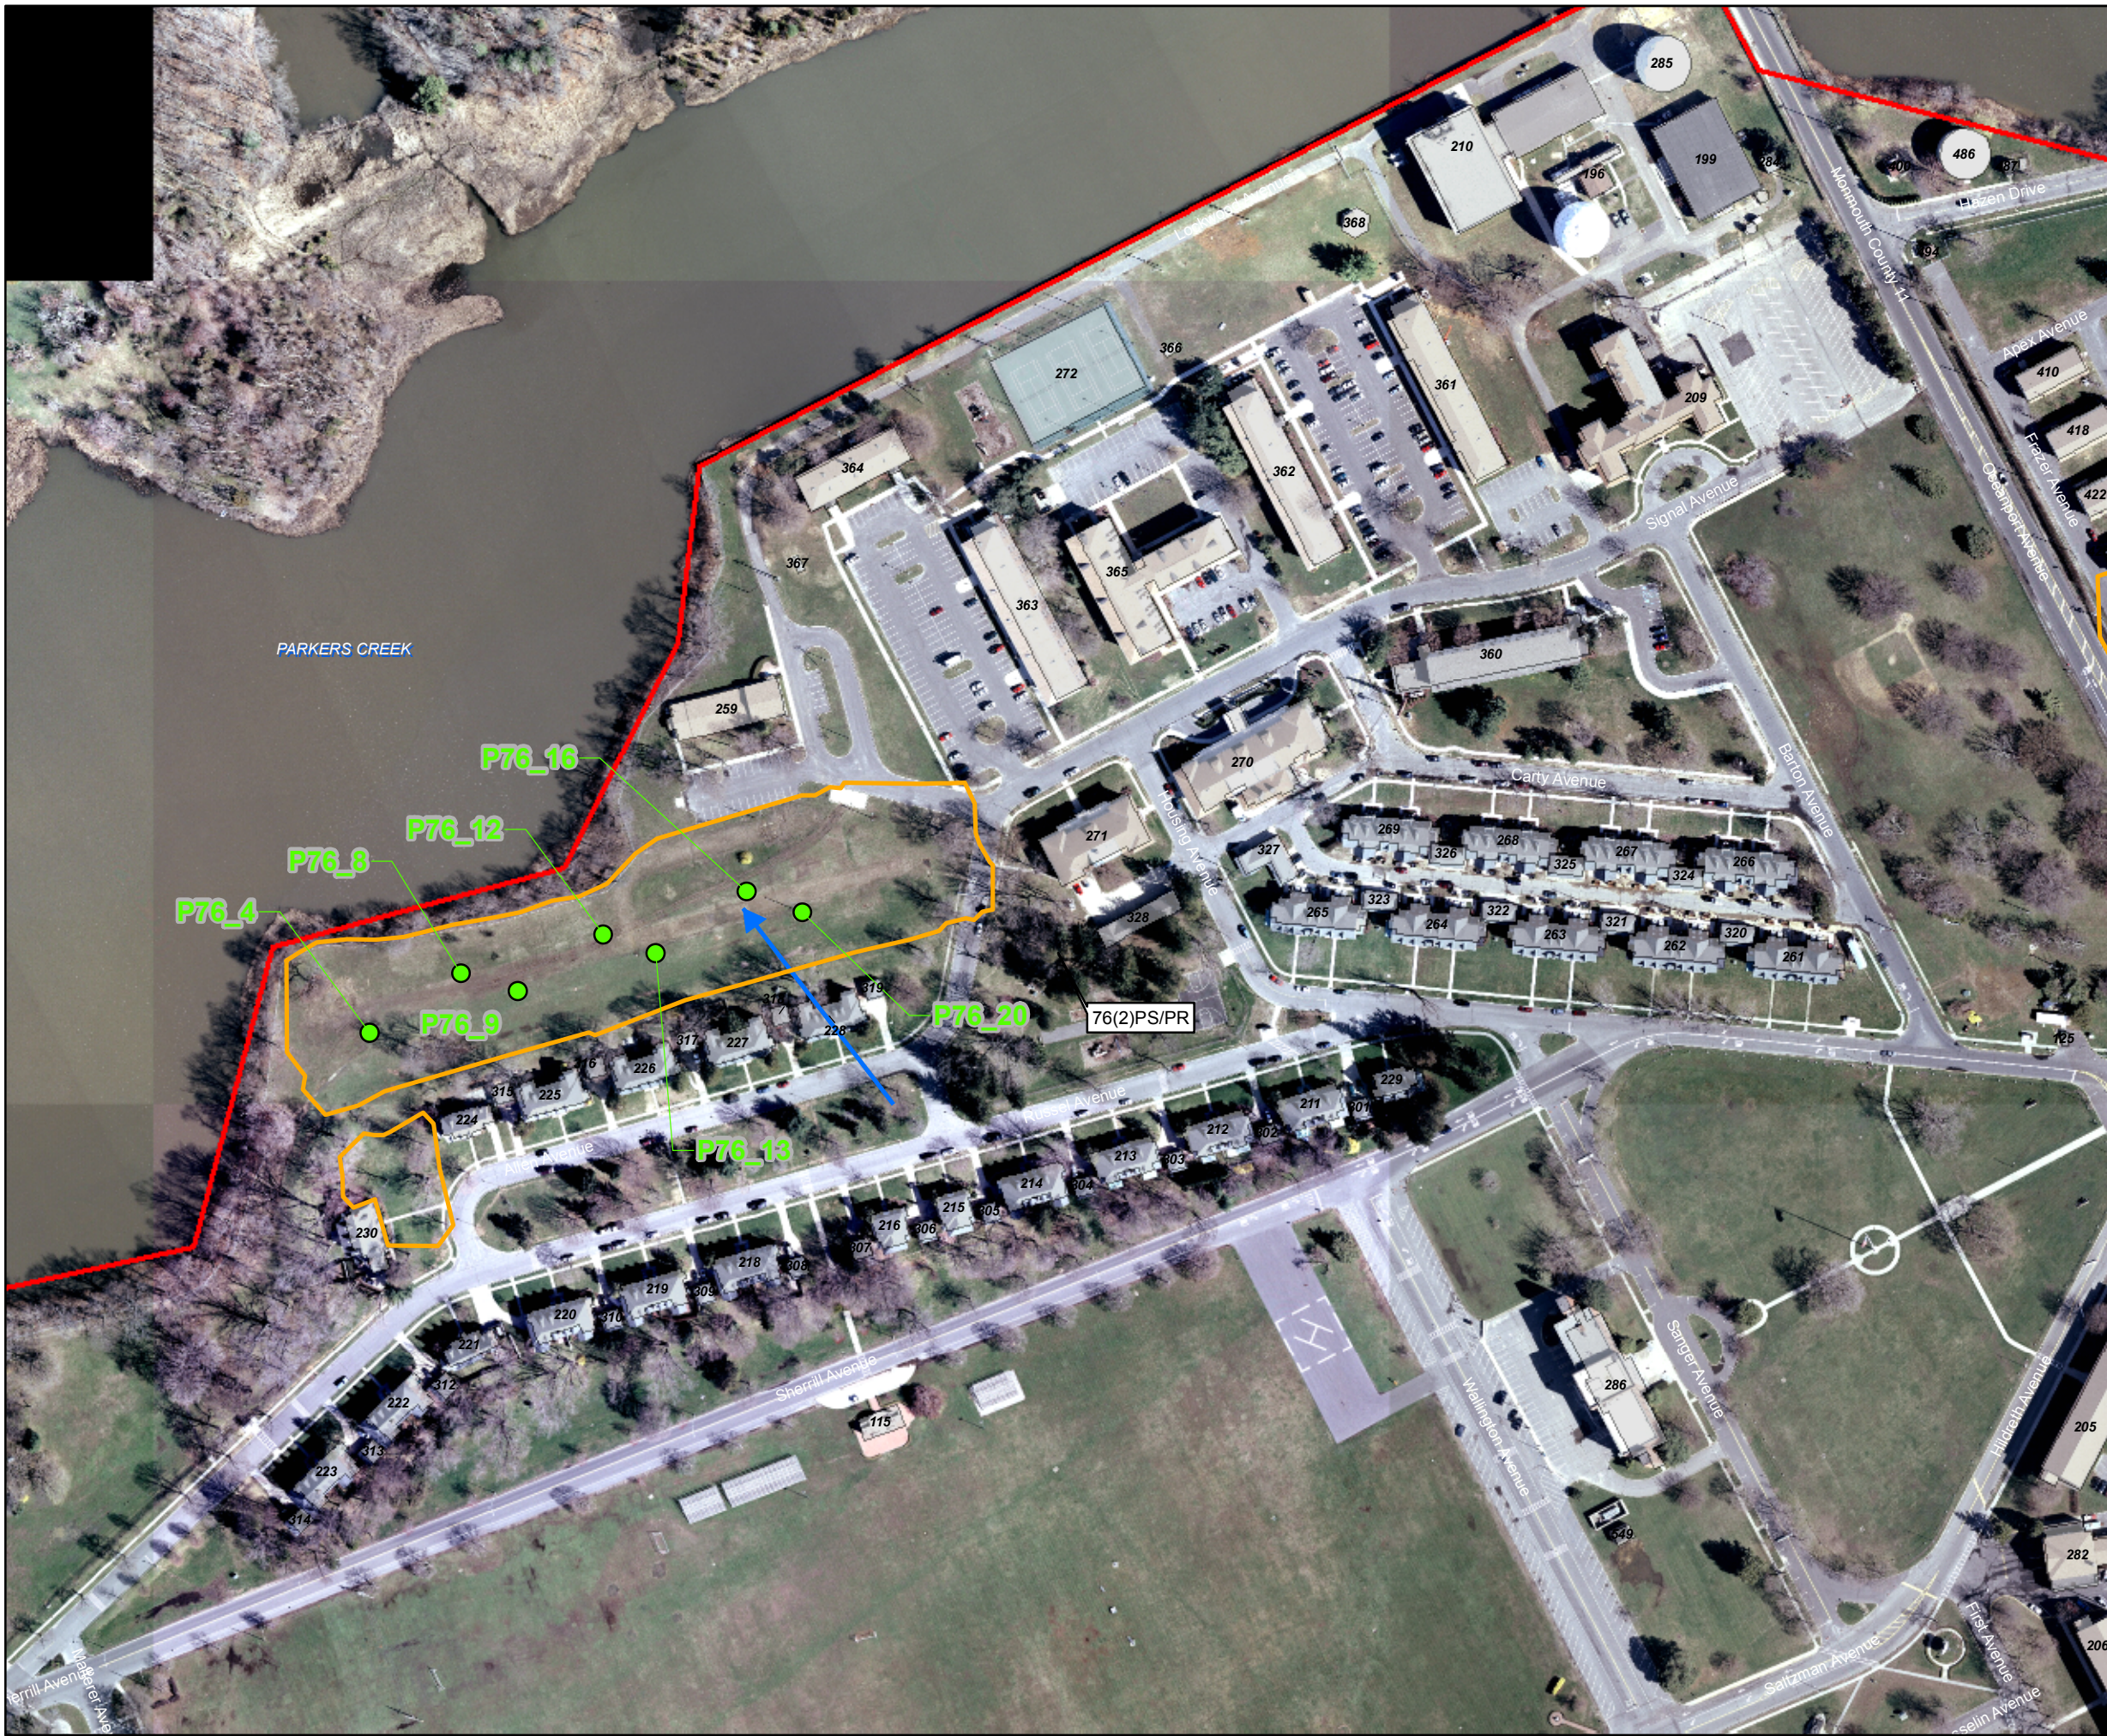
**FIGURE 3.18-2**  
**FORT MONMOUTH ECP**  
**SITE INVESTIGATION**  
**PARCEL 76**  
**SUSPECTED UST LOCATIONS**  
**MAIN POST**  
**FORT MONMOUTH**  
**NEW JERSEY**

The geophysical survey identified a total of 24 target EM anomalies. The survey areas are presented on **Figure 3.18-2**. This parcel of FTMM has been previously developed and the land surface reworked multiple times throughout its history. The findings of the geophysical survey (the density and small size of anomalies) are consistent with the site history. Seven suspected USTs were identified in the 300 Area; the locations of the suspected USTs are presented on **Figure 3.18-2**. No suspected USTs were identified in the area of Bldg 230. The results of the GPR/TW-6 follow-up scanning are listed in **Table 3.18-3**, and full results of the geophysical surveys are included in **Appendix A**. In summary, GPR scanning of the 24 targets revealed:

- Fourteen targets that were associated with surface metal/debris (previously unaccounted for).
- Three targets with moderate-amplitude scattered reflections, possible small pieces of scattered metal debris.

- Seven targets with high-amplitude parabolic reflections indicative of a possible UST. The suspected USTs match up with former Bldgs 537, 538, 539, 541, 542, 543, and 544. Said buildings served as barracks officers quarters, housing structures, until the end of their life cycles. Supporting real property records are included in **Appendix I**.

A total of seven targets indicative of suspected USTs were identified by the geophysical investigation. No constituents were identified above applicable NJDEP NRDCSCC or RDCSCC in surface or subsurface soil, and no constituents were identified above NJDEP GWQC in groundwater.
