3.22 Sanitary Sewer System

3.23 Electrical Substations

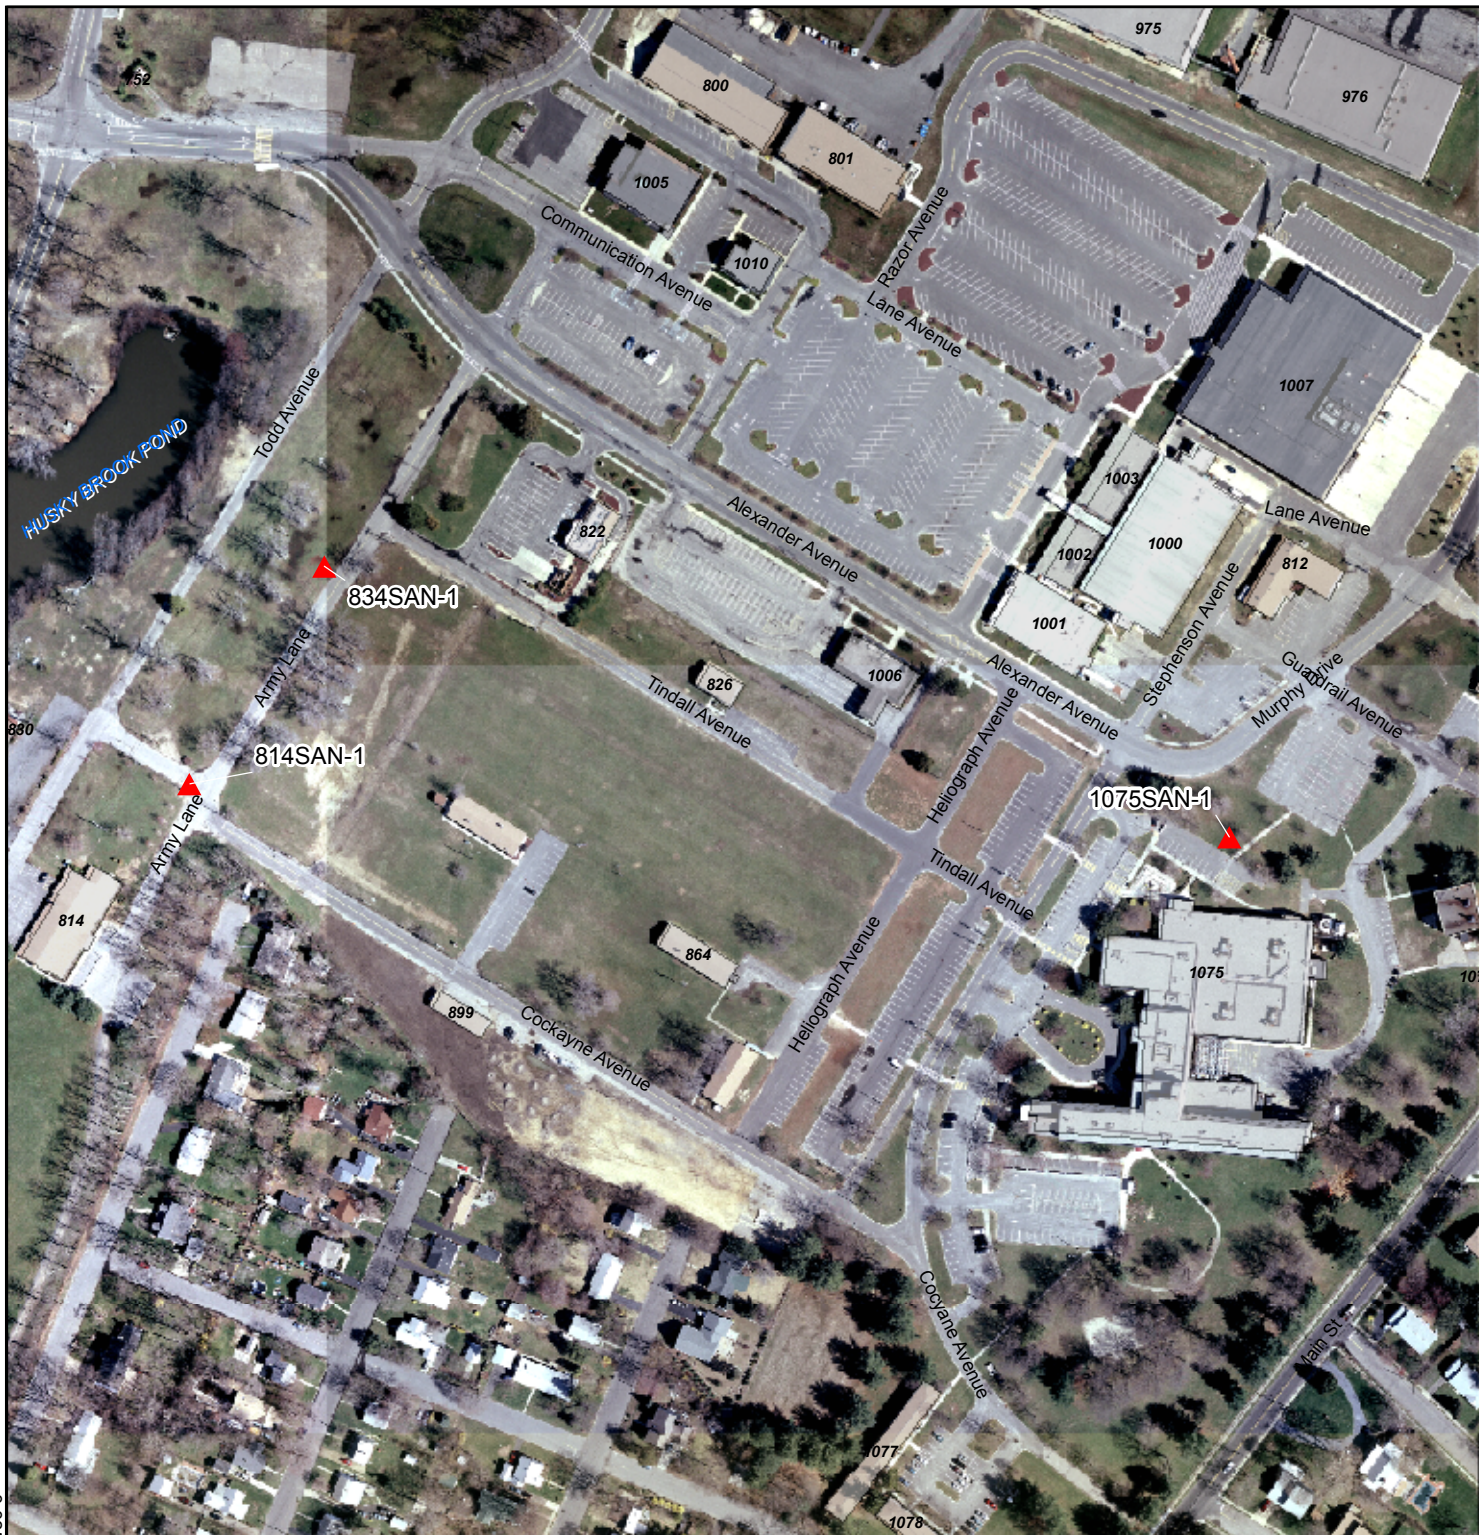
FIGURE 3.22-1
FORT MONMOUTH ECP
SITE INVESTIGATION
SANITARY SEWER SAMPLE LOCATIONS
BUILDINGS 814, 1075, AND FORMER
BUILDING 834
MAIN POST
FORT MONMOUTH
NEW JERSEY

Sanitary aqueous samples were collected at various manhole locations on the MP and one at the CWA in December 2007. A total of nine aqueous samples (including one duplicate sample) were collected from the sanitary sewer lines. A manhole located downgradient of Bldg 285 was concrete capped and abandoned. Therefore, investigation at this location could not be conducted.

Mercury was not detected in any of the collected sanitary aqueous samples.

Mercury was not identified in any samples. NFA is recommended.

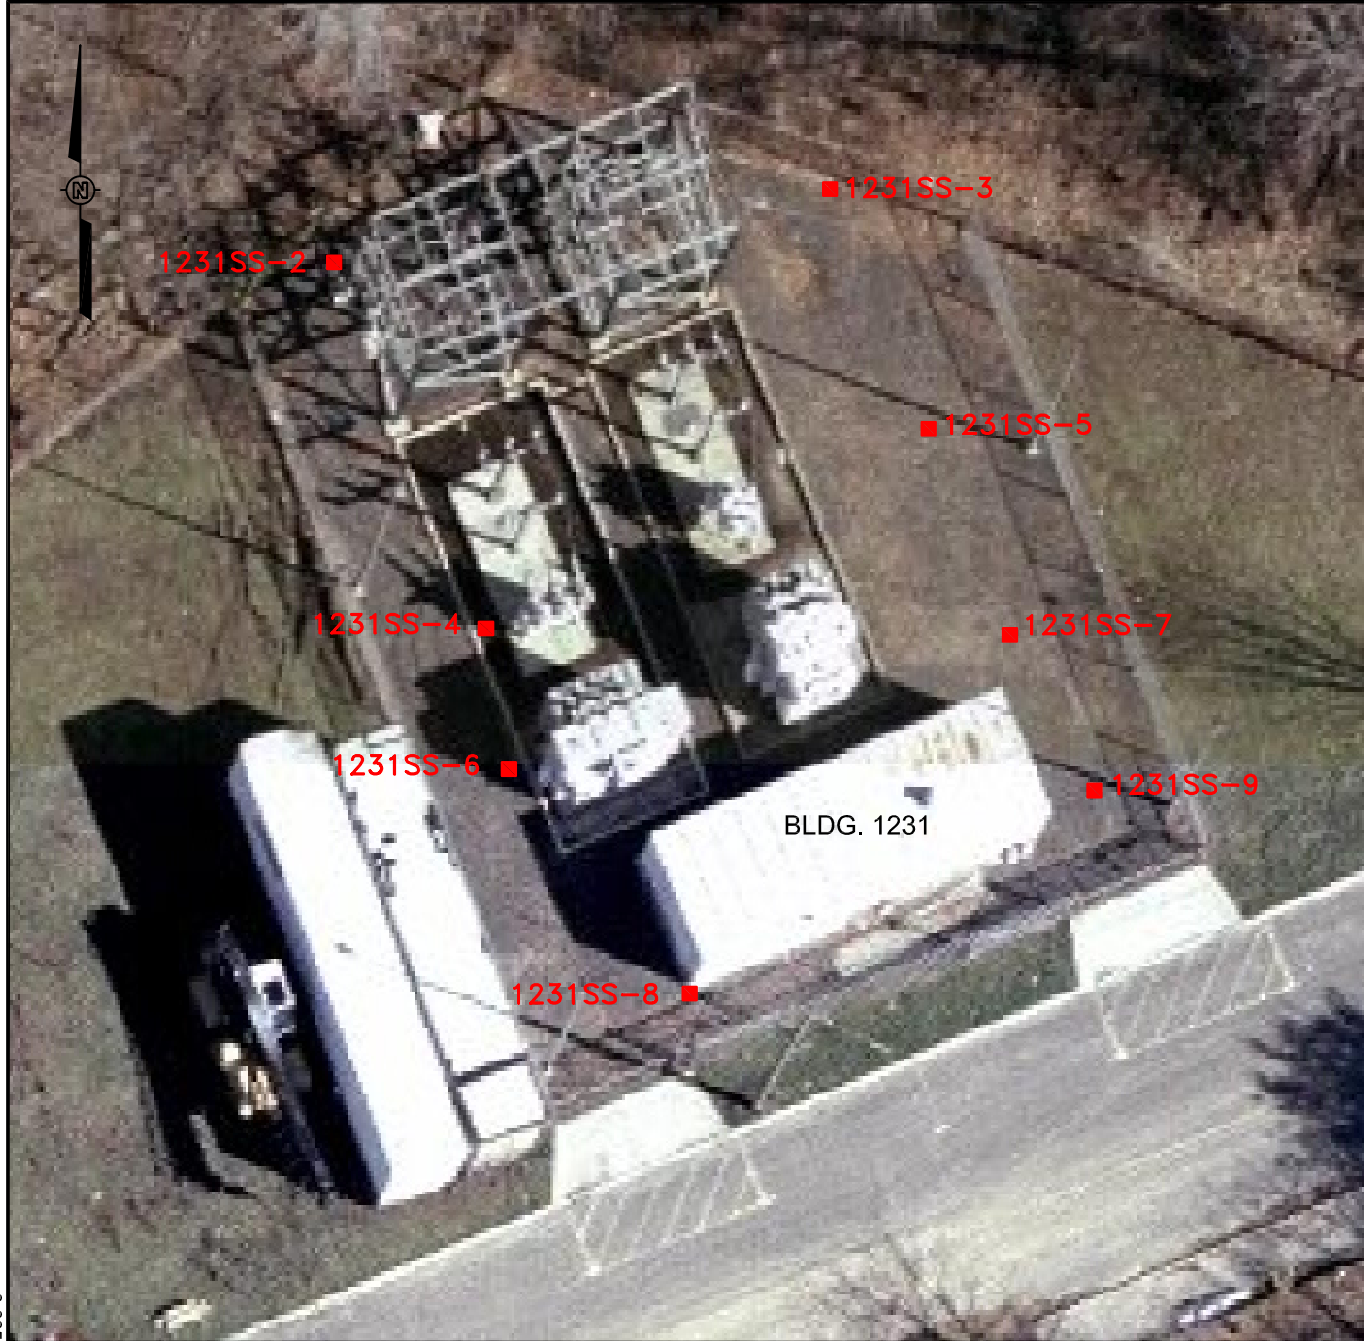
**FIGURE 3-23-2**
BLDG 1231 SAMPLE LOCATIONS
 MAIN POST
 FORT MONMOUTH
 NEW JERSEY

MP – Bldg 1231. A total of nine surface soil samples were collected from nine distinct hand augered sample locations in and around the Bldg 1231 substation (**Figure 3.23-2**). Surface soil samples for PCB analysis were collected from the 0- to 6-inch interval bgs. If sample locations were within gravel-covered areas, samples were collected from the 0- to 6-inch interval below the gravel sub-base.

No constituents were identified above the NRDCSCC in soil at any of the four substations. NFA is recommended.

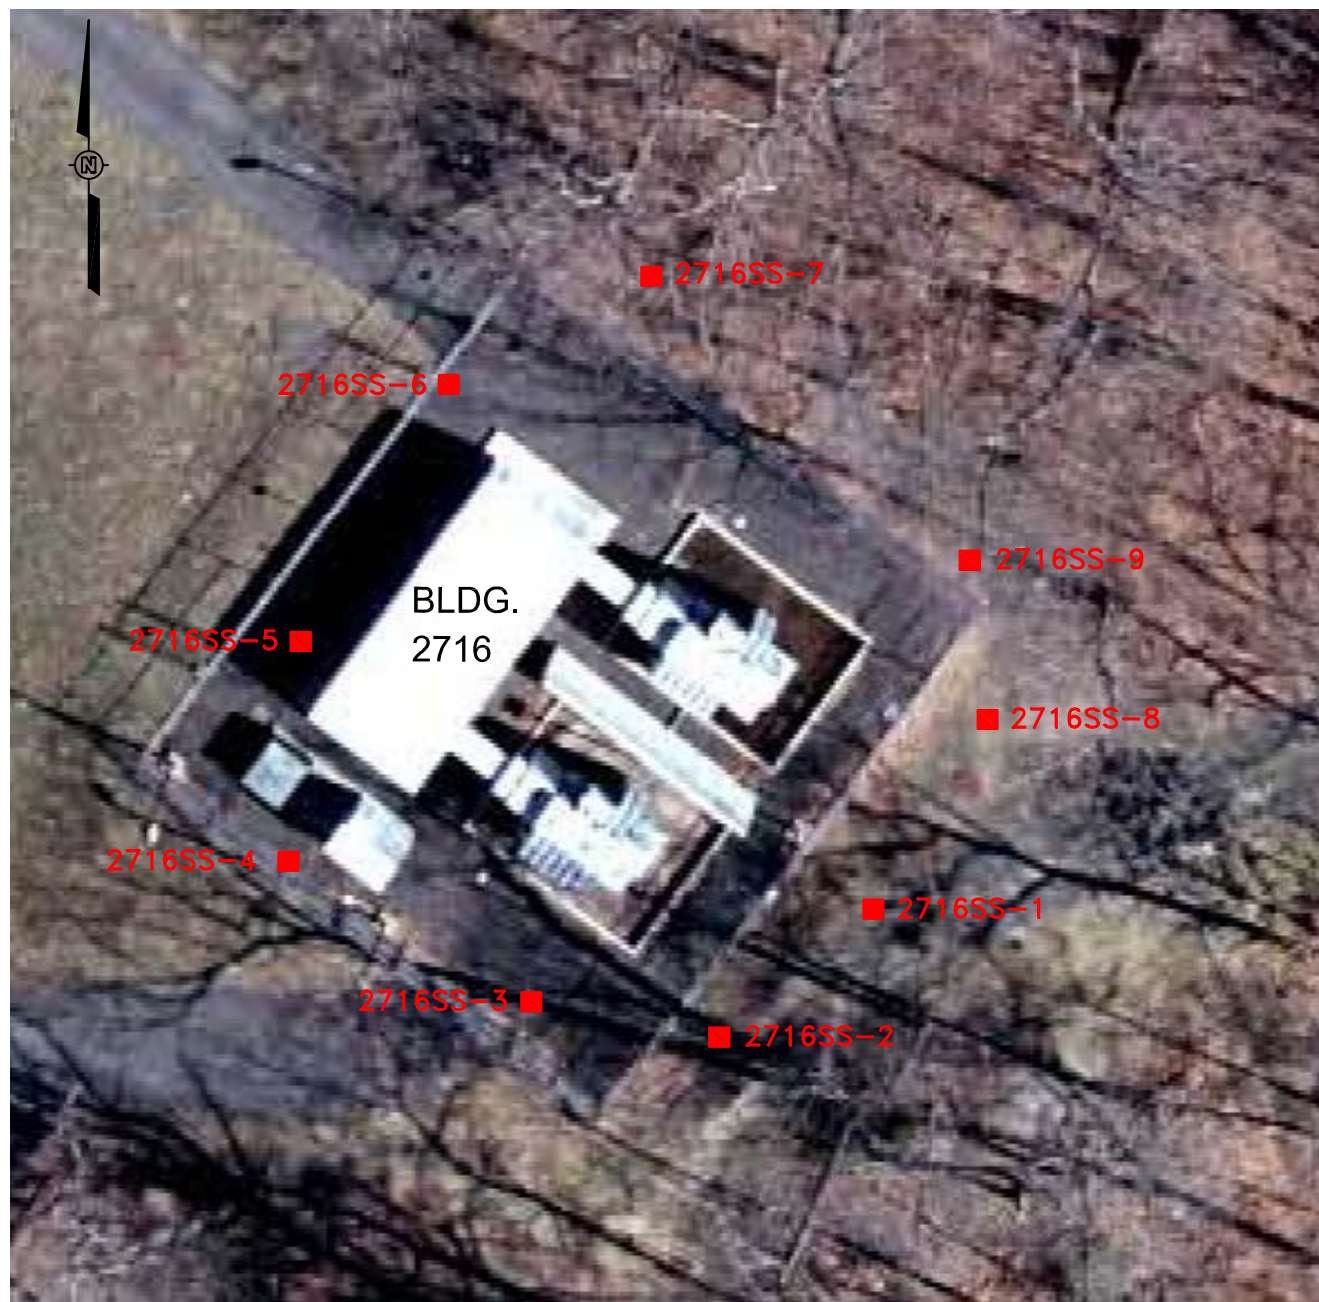
FIGURE 3-23-4
 BLDG 2716 SAMPLE LOCATIONS
 CHARLES WOOD AREA
 FORT MONMOUTH
 NEW JERSEY

CWA – Bldg 2716. A total of nine surface soil samples were collected from nine distinct hand auger boring locations in and around the Bldg 2716 substation (**Figure 3.23-4**). Surface soil samples for PCB analysis were collected from the 0- to 6-inch interval bgs. If sample locations were within gravel-covered areas, samples were collected from the 0- to 6-inch interval below the gravel sub-base.
