**HSA BUILDING FACT SHEET**

**Building No. / Name** Building #1075 (Patterson Health Clinic)  
**Installation** Fort Monmouth

**HSA and Addendum to Environmental Condition of Property  
Fort Monmouth**

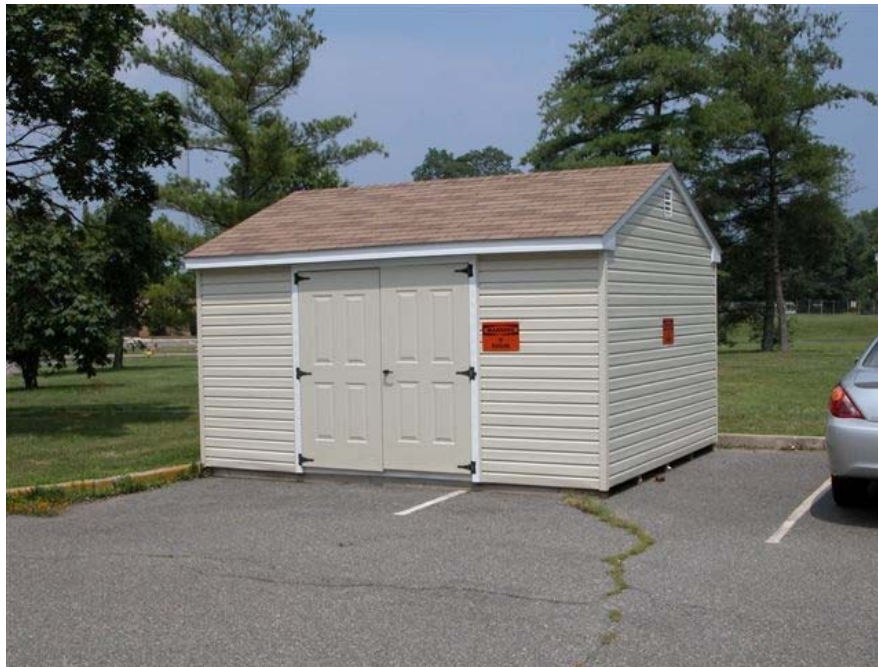
**Fort Monmouth, Building 1075 – Patterson Health Clinic, Hazardous Waste Storage**

the incinerator location appeared free of ash and debris (Ref. 079) and the site is considered "Response Complete" (Ref. 080). Currently, all hospital waste is now shipped off-site; Steris Cycle is contracted to remove hazardous medical waste, although there is no record of radioactive waste included with these materials.

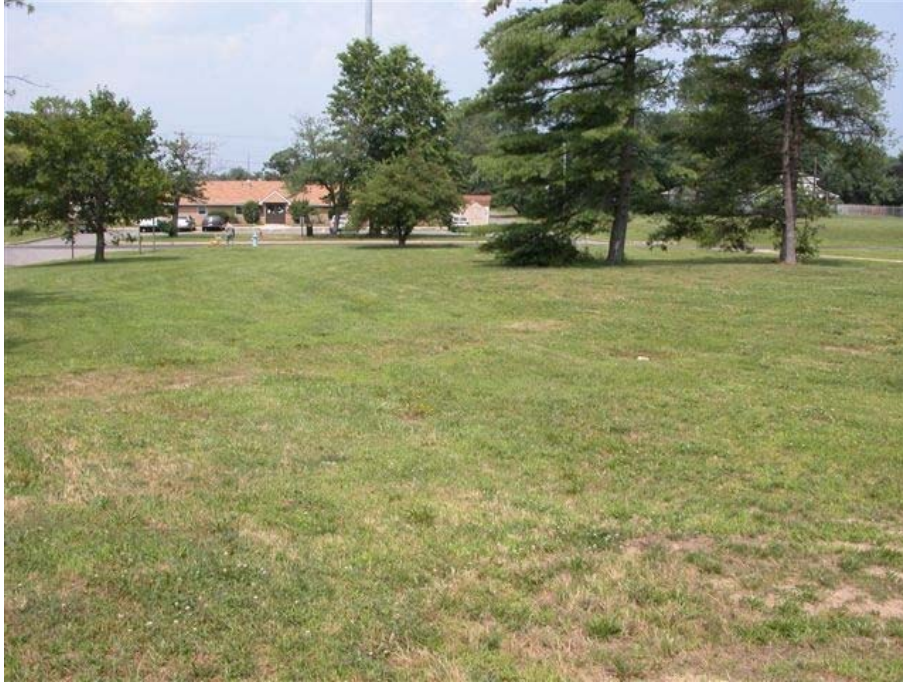
**Fort Monmouth, Building 1075 – Patterson Health Clinic,  
Possible location of former incinerator**

The hospital had used a pathological waste incinerator located on the west side of the building (from 1970 to 1992) to burn infectious paper and plastic and later Type 4 hospital waste (animal solids and organic wastes). Throughout its use, it tended to exceed emissions standards and was ultimately closed in 1992 and demolished in 1993. Following the demolition, the grounds around
