HSA BUILDING FACT SHEET

Building No. / Name Building #173
Installation Fort Monmouth

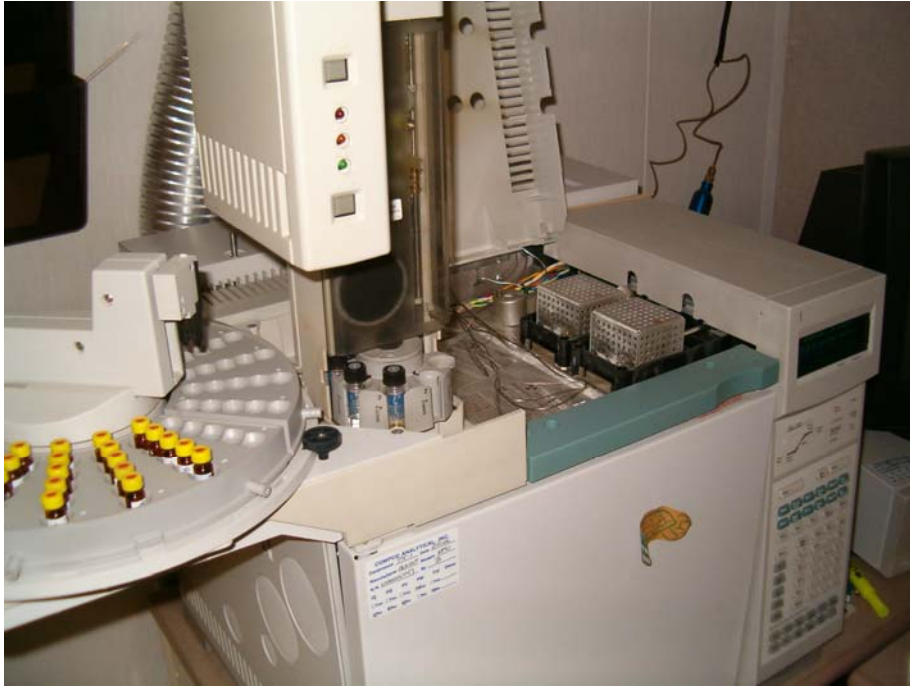
Six 15-mCi ECD (Electron Capture Detectors) are in use in the environmental lab, containing Ni-63 sources; used for pesticide and PCB analysis. The room is properly marked for radioactive materials. Environmental lab tests for gasoline spills, VOC measurements, monitoring well samples, drinking water samples, and explosives testing, but not radioactive analysis (must be sent to a different lab). The laboratory has two self-contained hoods with acid filters. No dosimetry is practiced in this laboratory; swipe test on Ni-63 source is only monitoring method, and is performed regularly with no evidence of leaks on record (Ref. 23).

Fort Monmouth, Building 173, Electron Capture Detector Containing Ni-63
