**HISTORICAL SITE ASSESSMENT
and
ADDENDUM TO ENVIRONMENTAL CONDITION OF
PROPERTY REPORT**

**FORT MONMOUTH
EATONTOWN, NEW JERSEY**

January 2007

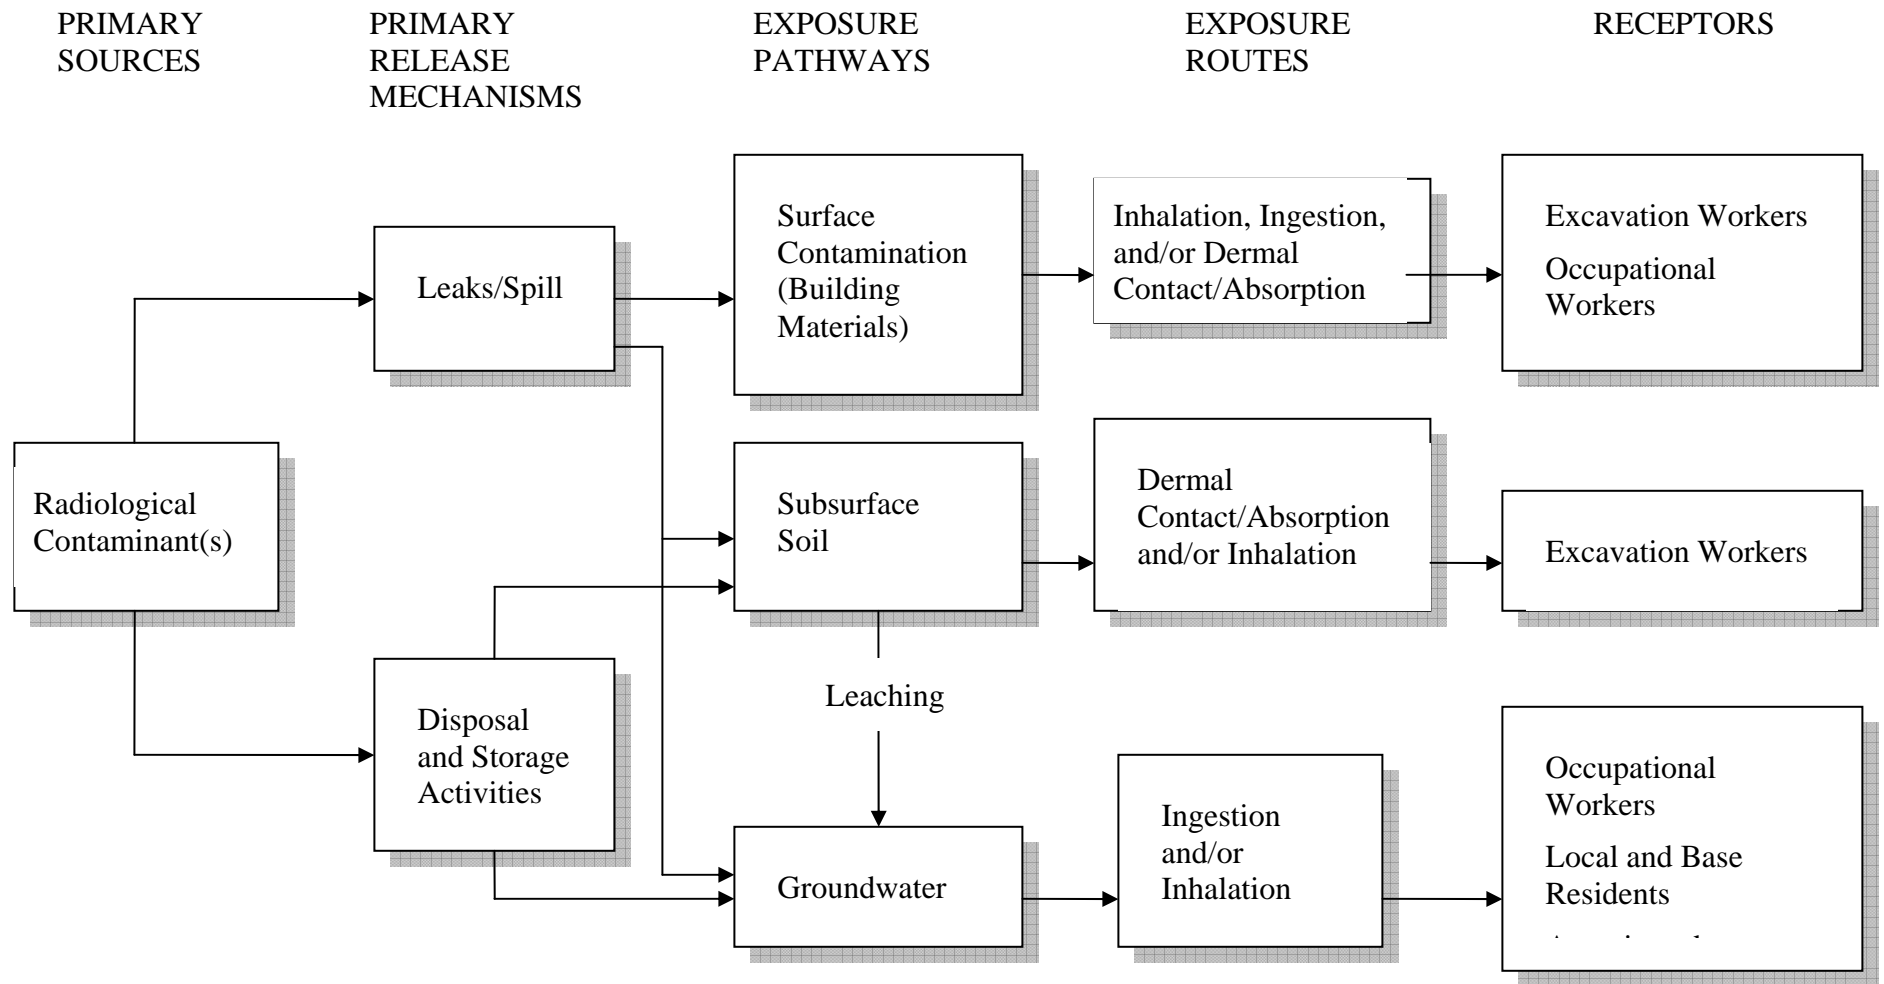
FIGURE 7-1: CONCEPTUAL SITE MODEL (CSM) FOR FORT MONMOUTH

Surface contamination of building materials (work surfaces, shelves, floors, walls, ceilings, etc.) is considered a primary transport mechanism. A secondary mechanism may be contaminants leaching from soil or from leaky drain/sewer systems to groundwater. This could occur through the network of tributaries throughout Fort Monmouth and shallow aquifers that ultimately drain into the Shrewsbury River.

- Inhalation, ingestion, and/or dermal contact with contaminants found on building materials and/or transfer of contamination following dermal contact to other materials;
- Dermal contact/absorption and/or inhalation with subsurface soils during excavation activities or with building materials during demolition activities;
- Ingestion and/or inhalation of leachate in surface water and sediment downgradient of contaminated soil areas;
- Inhalation, ingestion, and/or dermal contact with or absorption of groundwater downgradient of contamination sources.

Human receptors potentially include Fort Monmouth occupational workers who are in daily contact with radiological materials or work in and around potentially contaminated buildings. In addition, any excavation workers on the base who are involved in soil excavation or building demolition activities would be potential receptors. Base and off-site local residents are potentially impacted via transfer of contamination obtained through contact with commodities or building materials, as well as contact with contaminated groundwater. Ecological receptors potentially include aquatic wildlife and terrestrial plants and wildlife in and around the base area, which also can translate to human receptors through activities such as game hunting or fishing. The likelihood of impact to any of these receptors is minimal.
