March 19, 2015
ADDENDUM #2
TO
REQUEST FOR OFFERS TO PURCHASE
FOR
THE SALE OF REAL PROPERTY
HOWARD COMMONS

EXHIBIT A
Weston Report 3028 Pinebrook Housing

PINE BROOK HOUSING

3028.1 GENERAL

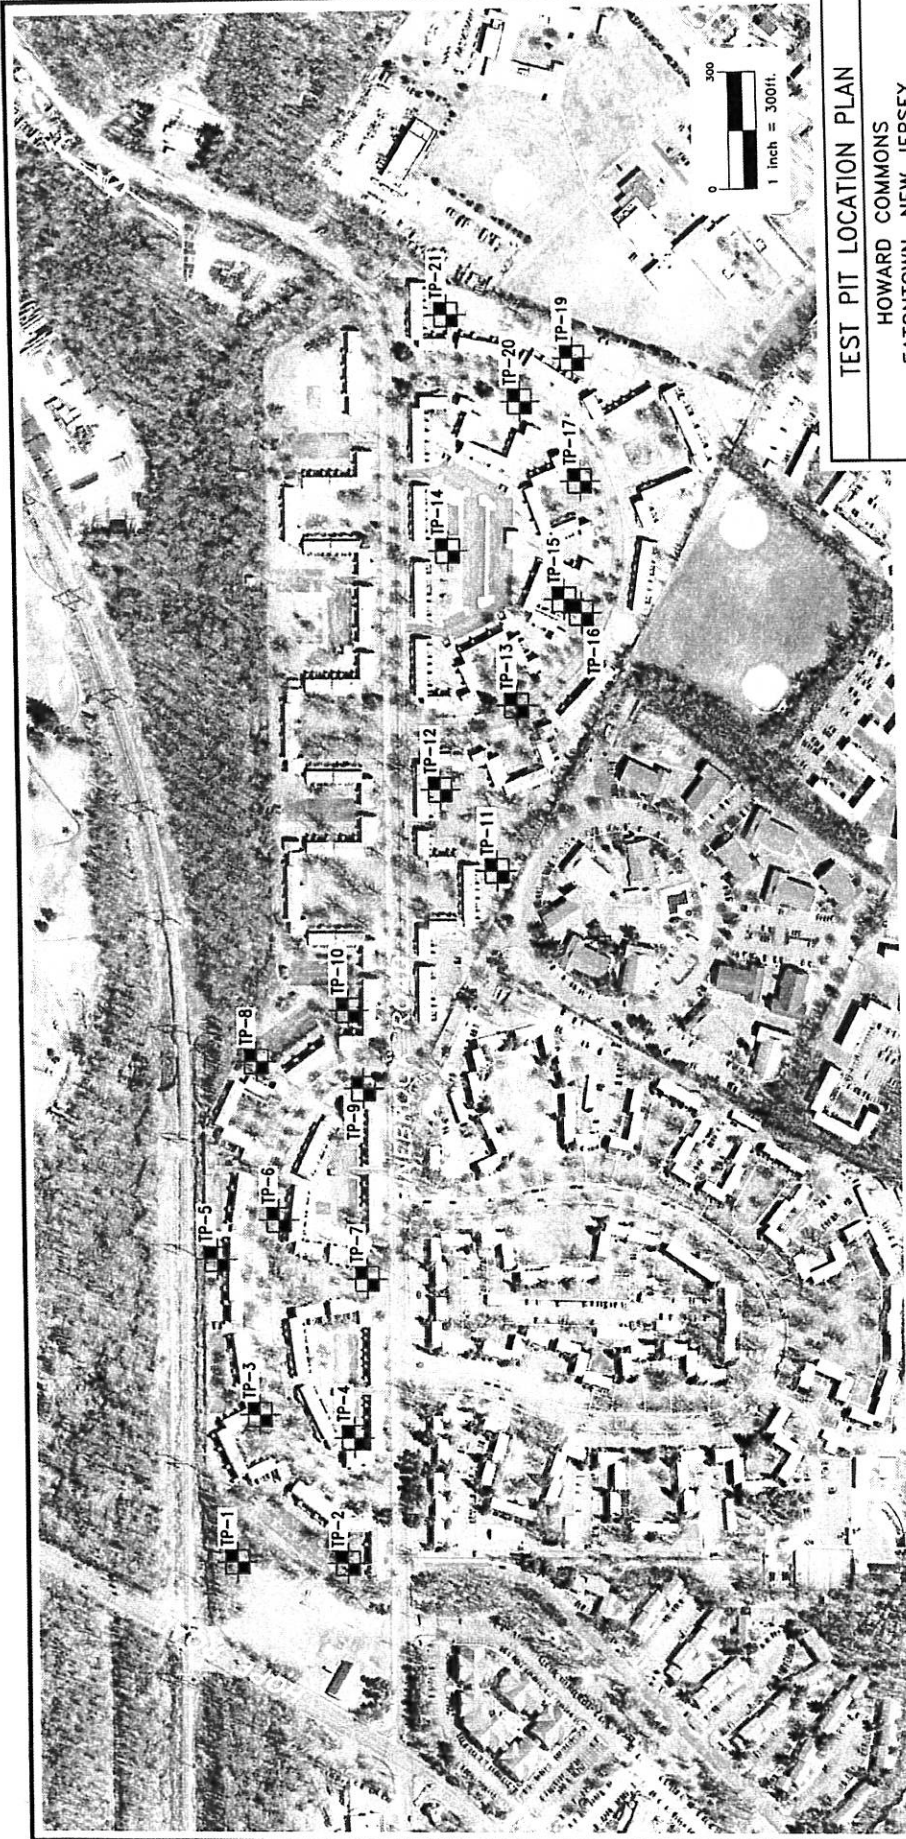
TEST PIT LOCATION PLAN

Test Pit #	Depth	Depth of Fill (ft)	Depth in feet to GW	Depth in feet to SHGW
1	8	NE	2.8	2
2	8.5	1.5	5	3.5
3	9	3	5	3.5
4	9	2	4.5	3.5
5	9	3	3.5	3
6	3	3	NE	
7	9	4	5	4
8	9	4	4.3	4
9	6	6	5.3	
10	9	2.5	4.5	3.5
11	10.5	3.5	5	3.5
12	8	2.5	5	2.5
13	4.5	2.5	4	2.5
14	8	2	3	2
15	9	2.5	5	2.7
16	8	3	3	3
17	9	2	5	2.5
18	Test pit not completed due to existing utilities			
19	8	NE	3.5	2
20	8	1.5	3	2
21	8	NE	4	2
